WOOD DESTROYING PESTS AND ORGANISMS INSPECTION REPORT

Building No. 4404	Street, City, Zip W Kling St, Burbank, CA 91505	Date of Inspection 9/22/2020	No. of Pages 6

Higgins Termite, Inc. 8630 Lankershim Blvd Sun Valley, Ca 91352 818 768 2614	
Firm Registration No. PR 1195		Report No. 4482K	Escrow No.
Property Owner: Wayne, Teresa 4404 W Kling St Burbank, CA 91505		Party of Interest: Mendez, Erik Toluca Townhome III C/O Onit Property Management 10153 1/2 Riverside Dr Suite 335 Toluca Lake, CA 91602	Report Sent To: Mendez, Erik 10153 1/2 Riverside Dr Suite 335 Toluca Lake, CA 91602
COMPLETE REPORT <input type="checkbox"/> LIMITED REPORT <input checked="" type="checkbox"/> SUPPLEMENTAL REPORT <input type="checkbox"/> REINSPECTION REPORT <input type="checkbox"/>			
General Description: One of a multi story multi unit townhome complex with stucco covered over wood frame and attached garage.		Inspection Tag Posted: Under Master Bathroom Sink.	
		Other Tags Posted: None Noted.

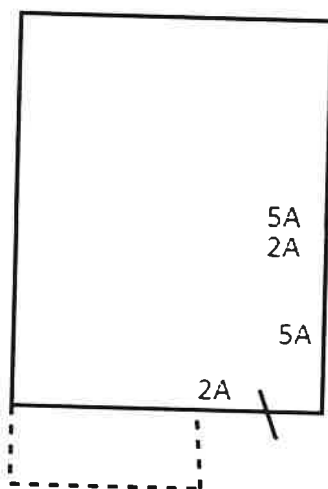
Diagram not to scale findings at approximate locations, not for escrow purposes.

FINDING: Evidence of kaloterme swarmers (drywood termite) noted at master bedroom bathroom and attic frame. Infestation may extend into inaccessible areas.
** This is a Section 1 Item **

FINDING: Attic was limited for inspection due to construction type.
** This is a Further Inspection Item **

Seal the structure and fumigate with an approved fumigant for the eradication of kaloterme (drywood termite). The structure must be vacated until the fumigation is complete.

In lieu of fumigation, at the request of Toluca Townhome III C/O Onit Property Management, chemically treat all visible and accessible infestation with an approved chemical as indicated. Cover or remove evidence after treatment.

Further inspection is recommended and issue a supplemental report on conditions found. An additional cost may be issued for re-inspections.
