WOOD DESTROYING PESTS AND ORGANISMS INSPECTION REPORT

Building No. 4410	Street, City, Zip W Kling St, Burbank, CA 91505	Date of Inspection 01/19/2022	No. of Pages 7
Higgins Termite, Inc. 8630 Lankershim Blvd Sun Valley, Ca 91352 818 768 2614

Firm Registration No. PR 1195		Report No. 3582B	Escrow No.
Property Owner: Wendy Goldfisher 4410 W Kling St Burbank, CA 91505 213-379-4459		Party of Interest: Toluca Townhome III C/O Partners Community Management 260 S Los Robles Ave Suite 307 Pasadena, CA 91101	Report Sent To: Wendy Goldfisher 4410 W Kling St Burbank, CA 91505
COMPLETE REPORT <input type="checkbox"/> LIMITED REPORT <input checked="" type="checkbox"/> SUPPLEMENTAL REPORT <input type="checkbox"/> REINSPECTION REPORT <input type="checkbox"/>			
General Description: Multi-Unit Multi-Story Stucco and Frame Townhome Complex.		Inspection Tag Posted: Stairway to Garage Other Tags Posted: None Posted	
An inspection has been made of the structure(s) shown on the diagram in accordance with the Structural Pest Control Act. Detached porches, detached steps, detached decks and any other structures not on the diagram were not inspected.

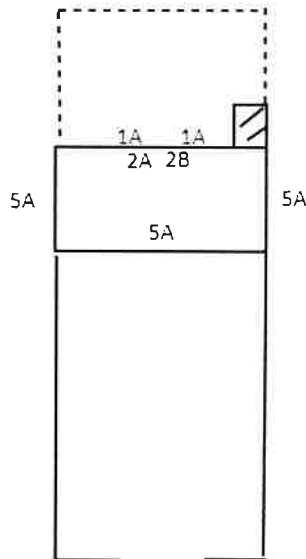
Diagram NOT to scale findings at approximate locations NOT for Escrow Purposes

Item1A FINDING: Evidence of subterranean termites noted at exposed walls of front room.
** This is a Section 1 Item **

Item2A FINDING: Evidence of kaloterme (drywood termite) noted at exposed plywood floor at front room by slider. Infestation may extend into inaccessible areas.
** This is a Section 1 Item **

Item2B FINDING: Slight Kaloterme (drywood termite) damage noted at exposed hardwood floor at slider.
** This is a Section 1 Item **

Item5A FINDING: Evidence of subterranean termites noted at exposed wall at both sides of front room area by slider.
** This is a Further Inspection Item **

RECOMMENDATION: Drill holes through concrete slab and inject an approved termiticide, in accordance with the manufacturer's label for the control of subterranean termites, seal holes with cement/non cellulose plug, and scrape down and or remove subterranean termite evidence. (NOTE: HIGGINS TERMITE INC. IS NOT RESPONSIBLE FOR POSSIBLE DAMAGE TO HIDDEN PIPES AND/OR FLOOR COVERINGS DURING PROCESS OF TREATMENT).
1A.1

RECOMMENDATION: Trench and treat small area by front room slider door at patio.
1A.2

RECOMMENDATION: Seal the structure and fumigate with an approved fumigant for the eradication of kaloterme (drywood termite). The structure must be vacated until the fumigation is complete.
2A.1
NOTE: Every precaution will be taken during the process of fumigation. However, Higgins Termite Inc., assumes no responsibility for any damage to roofs, plants, paint or antennas. Fumigation includes a two (2) year warranty. Higgins Termite will cover or remove pellets after treatment.

RECOMMENDATION: Owner/responsible party to employ a licensed contractor to remove/replace all damaged wood. If damage extends into inaccessible areas, a supplemental report will be issued with additional findings and costs.

RECOMMENDATION: Further inspection is recommended of adjacent Units, sub areas and issue a supplemental report on conditions found. An additional cost may be issued for re-inspections.
