WOOD DESTROYING PESTS AND ORGANISMS INSPECTION REPORT

Building No. 354	Street, City, Zip N Clybourn Ave, Burbank, CA 91505	Date of Inspection 12/17/2020	No. of Pages 6

Higgins Termite, Inc. 8630 Lankershim Blvd Sun Valley, Ca 91352 818 768 2614	
Ordered By: Salmon, Ivette 354 N Clybourn Ave Burbank, CA 91505		Firm Registration No. PR 1195	
Report No. 9017D		Escrow No.	
Property Owner: Salmon, Ivette 354 N Clybourn Ave Burbank, CA 91505		Party of Interest: Stevenson, Alex Toluca Townhome III C/O Partners Community Management 260 S Los Robles Ave Suite 307 Pasadena, CA 91101	
Report Sent To: Stevenson, Alex 260 S Los Robles Ave Suite 307 Pasadena, CA 91101		COMPLETE REPORT <input type="checkbox"/> LIMITED REPORT <input checked="" type="checkbox"/> SUPPLEMENTAL REPORT <input type="checkbox"/> REINSPECTION REPORT <input type="checkbox"/>	
General Description: One unit of a multi-story, multi-unit townhome complex with stucco covered over wood frame and attached garage.		Inspection Tag Posted: Under kitchen sink.

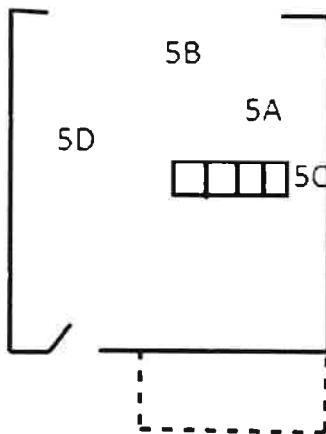
Diagram not to scale findings at approximate locations, not for escrow purposes.
