WOOD DESTROYING PESTS AND ORGANISMS INSPECTION REPORT

Building No. 4400	Street, City, Zip W - 4456 Kling St, Burbank, CA 91505	Date of Inspection 12/11/2021	No. of Pages 19
Higgins Termite, Inc. 8630 Lankershim Blvd Sun Valley, Ca 91352 818 768 2614

Firm Registration No. PR 1195		Report No. 134_R	
Property Owner: Toluca Townhomes III 4400 W - 4456 Kling St Burbank, CA 91505		Party of Interest: Toluca Townhome III C/O Partners Community Managem 260 S Los Robles Ave Suite 307 Pasadena, CA 91101	
Ordered By: Toluca Townhome III C/O Partners Community Managem 260 S Los Robles Ave Suite 307 Pasadena, CA 91101		Escrow No.	
Report Sent To: Toluca Townhome III C/O Partners Community Managem 260 S Los Robles Ave Suite 307 Pasadena, CA 91101		Report No.	
COMPLETE REPORT <input checked="" type="checkbox"/> LIMITED REPORT <input type="checkbox"/> SUPPLEMENTAL REPORT <input type="checkbox"/> REINSPECTION REPORT <input type="checkbox"/>			
General Description: Multi story multi unit townhome complex with stucco cover over wood frame and attached garage.		Inspection Tag Posted: Meter Cabinet Adjacent To Unit 4438.

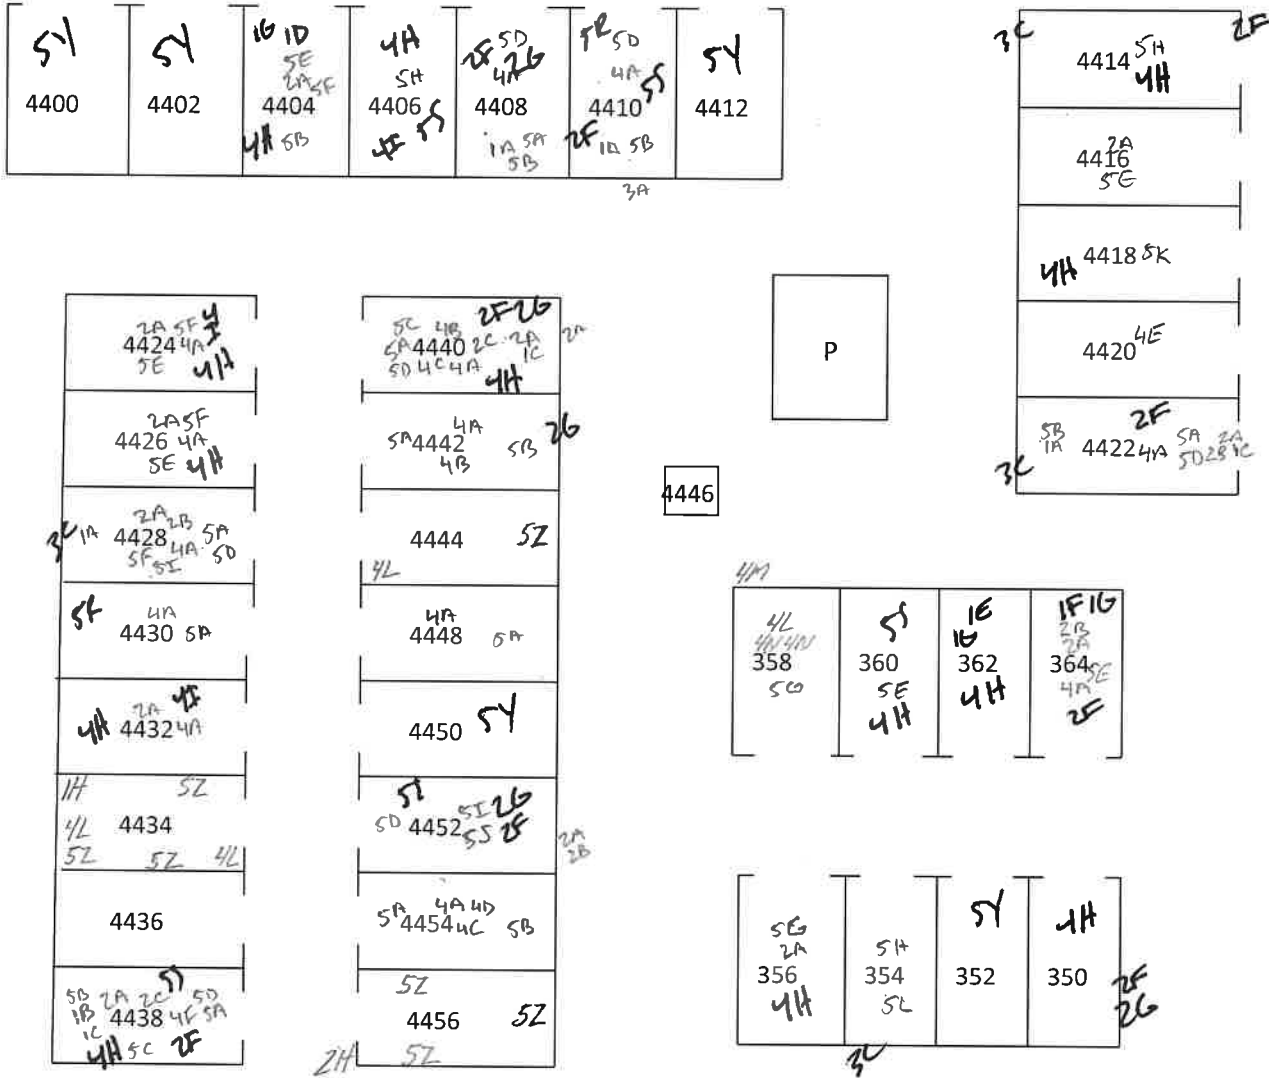
FINDING: Subterranean termite evidence noted penetrating concrete slab from earth fill at unit 4434 garage bonus room front joist as designated on diagram.
** This is a Section 1 Item **
