# WOOD DESTROYING PESTS AND ORGANISMS INSPECTION REPORT

Building No. 356	Street, City, Zip N Clybourn Ave, Burbank, CA 91505	Date of Inspection 10/07/2021	No. of Pages 6
Higgins Termite, Inc. 8630 Lankershim Blvd Sun Valley, Ca 91352 818 768 2614

Note: This is a limited inspection report requested by Aida Poladian, limited to master bedroom only. It is recommended that further inspection of the entire structure be made in accordance with the Structural Pest Control regulations.

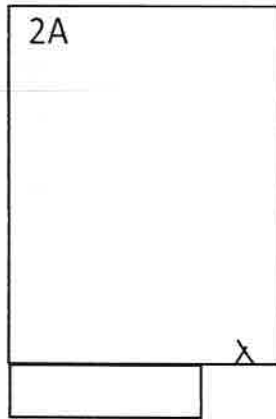
Diagram not to scale, findings at approximate location.  
Not for escrow purposes.

FINDING: Evidence of kaloterme (drywood termite) noted at master bedroom window. Infestation may extend into inaccessible areas.

Seal the structure and fumigate with an approved fumigant for the eradication of kaloterme (drywood termite). The structure must be vacated until the fumigation is complete.

In lieu of fumigation, at the request of Toluca Townhome III C/O Partners Community Management, chemically treat all visible and accessible infestation with an approved chemical as indicated. Cover or remove evidence after treatment.
