WOOD DESTROYING PESTS AND ORGANISMS INSPECTION REPORT

Building No. 358	Street, City, Zip Clybourn Ave, Burbank, CA 91505	Date of Inspection 12/17/2020	No. of Pages 6

Higgins Termite, Inc. 8630 Lankershim Blvd Sun Valley, Ca 91352 818 768 2614	
Ordered By: Phinnessee, Darnell 358 Clybourn Ave Burbank, CA 91505			
Firm Registration No. PR 1195	Report No. 134_32C	Escrow No.	
Property Owner: Phinnessee, Darnell 358 Clybourn Ave Burbank, CA 91505	Party of Interest: Stevenson, Alex Toluca Townhome III C/O Partners Community Management 260 S Los Robles Ave Suite 307 Pasadena, CA 91101	Report Sent To: Stevenson, Alex 260 S Los Robles Ave Suite 307 Pasadena, CA 91101	
COMPLETE REPORT <input type="checkbox"/> LIMITED REPORT <input checked="" type="checkbox"/> SUPPLEMENTAL REPORT <input type="checkbox"/> REINSPECTION REPORT <input type="checkbox"/>			
General Description: One unit of a multi-story, multi-unit townhome complex with stucco covered over wood frame and attached garage.		Inspection Tag Posted: Under kitchen sink.

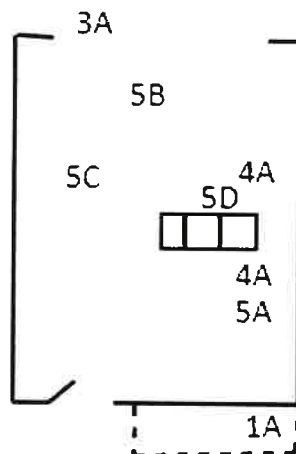
Diagram not to scale findings at approximate locations, not for escrow purposes.
