WOOD DESTROYING PESTS AND ORGANISMS INSPECTION REPORT

Building No. 4400	Street, City, Zip W - 4456 Kling St, Burbank, CA 91505	Date of Inspection 3/4/2020	No. of Pages 6

Note: This is a limited inspection report requested by HOA President Mrs. Phillips, limited to the exposed balcony railing and small amount of balcony landing of Units 4448 and 4450 only. It is recommended that further inspection of the entire structure be made in accordance with the Structural Pest Control regulations.

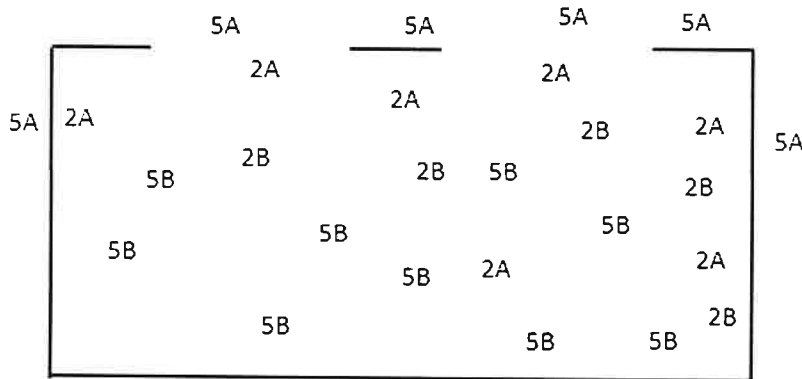
Diagram NOT to scale findings at approximate locations
NOT for Escrow Purposes

FINDING: Evidence of kaloterme (drywood termite) noted at exposed railing and flooring at balconies of Units 4448 and 4450. Infestation may extend into inaccessible areas.
** This is a Section 1 Item **

FINDING: Kaloterme (drywood termite) damage noted at exposed balcony railing and small area of exposed balcony flooring.
** This is a Section 1 Item **

FINDING: Kaloterme drywood termite damage noted at balcony railing.
** This is a Further Inspection Item **

FINDING: Kaloterme drywood termite damage at small area of exposed flooring of balcony.
** This is a Further Inspection Item **

Rec 2A.1
RECOMMENDATION: Seal the structure and fumigate with an approved fumigant for the eradication of kaloterme (drywood termite). The structure must be vacated until the fumigation is complete.

Rec 2A.2
RECOMMENDATION: In lieu of fumigation, at the request of Toluca Townhomes III C/O Onit Property Management, chemically treat all visible and accessible infestation with an approved chemical as indicated. Cover or remove evidence after treatment.

Rec 2A.3
RECOMMENDATION: In lieu of fumigation, at the request of owner's, treat drywood termites with an electro-pest gun in visible and accessible areas and cover or remove evidence where possible with the understanding that this may not eliminate the termites in inaccessible areas.

RECOMMENDATION: Owner/responsible party to employ a licensed contractor to remove/replace all damaged wood. If damage extends into inaccessible areas, a supplemental report will be issued with additional findings and costs.

RECOMMENDATION: Expose balcony further for further inspection is recommended and issue a supplemental report on conditions found. An additional cost may be issued for re-inspections.

RECOMMENDATION: Expose area of flooring further inspection is recommended and issue a supplemental report on conditions found. An additional cost may be issued for re-inspections.
