# WOOD DESTROYING PESTS AND ORGANISMS INSPECTION REPORT

Building No. 4400	Street, City, Zip W - 4456 Kling St, Burbank, CA 91505	Date of Inspection 11/21/2020	No. of Pages 17

Diagram On Page 2

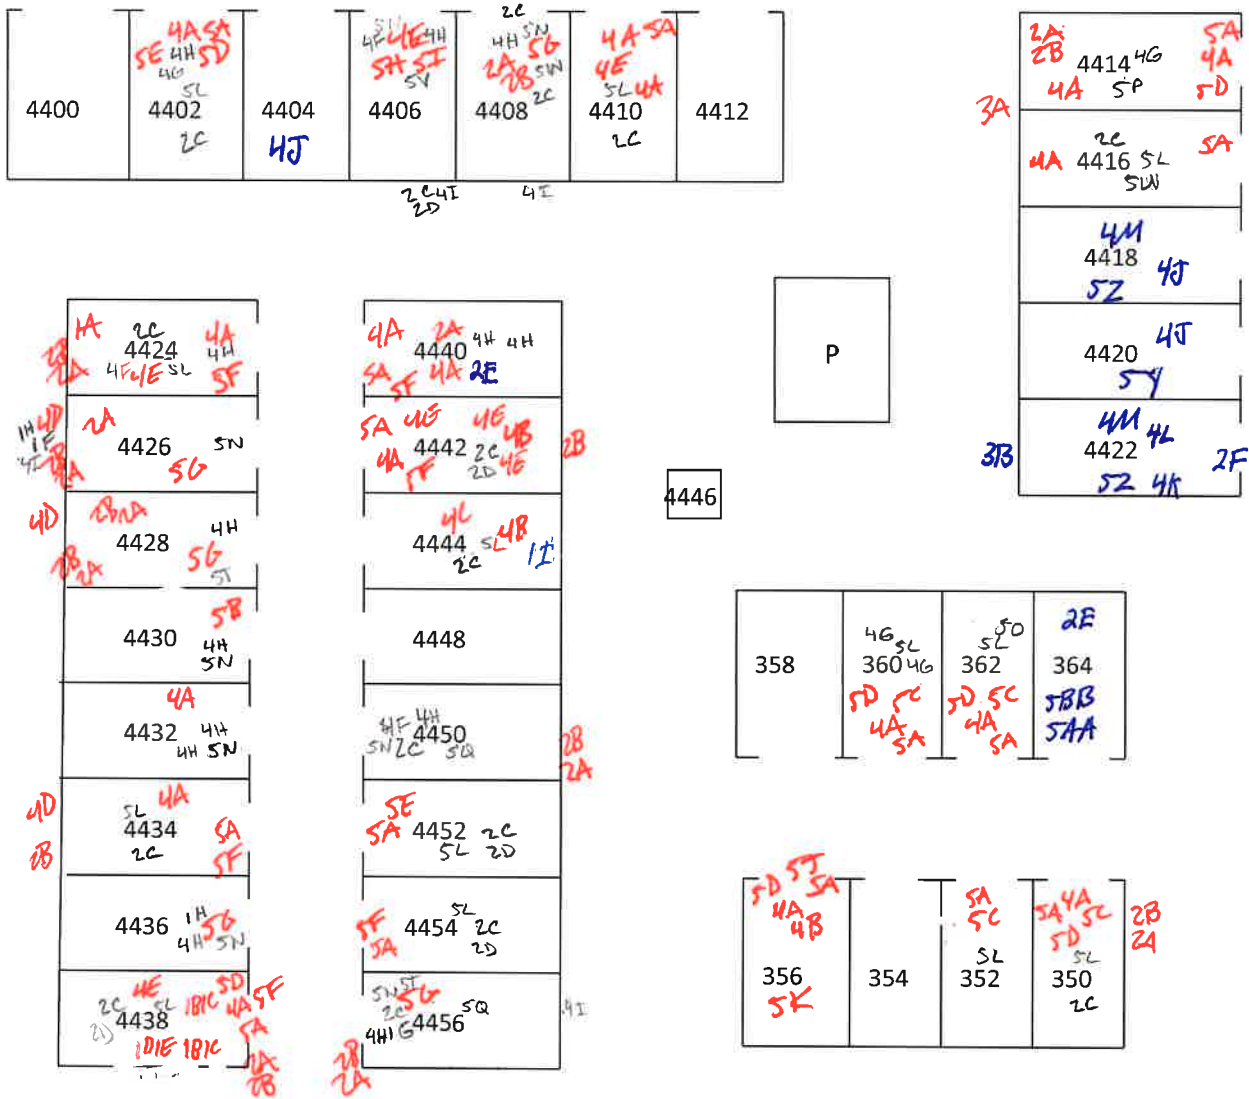
PAGE 2 OF STANDARD INSPECTION REPORT ON PROPERTY AT:

**NOTE: Diagram Not To Scale Findings At Approximate Locations, Not For Escrow Purposes.**
